Coombe Dingle Stove Report

STOVAX STOCKTON 11 Wood stove

CLEARVIEW 650

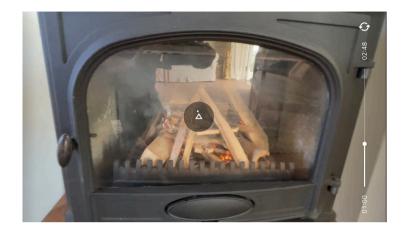
At 60 seconds

Chamber full of smoke and fire struggling to take hold.

The Stockton 11 has been disappointing from the word go. We struggled to light it and in the end purchased a generic fire grate to help. Even opening the door slowly to allow equalising of pressures in and outside of the stove never really helped with the smoke spillage when refuelling, which was ever present. At times the smoke was so bad it meant we had to leave the room. Worse, it triggered the CO monitor.

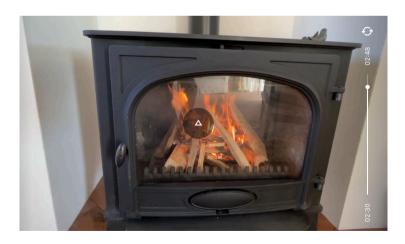
At 150 seconds

Door still ajar, fire beginning to establish
